## Preserving Poonch House: Architectural Documentation, Historical Insights, and Conservation Challenges

### Abstract

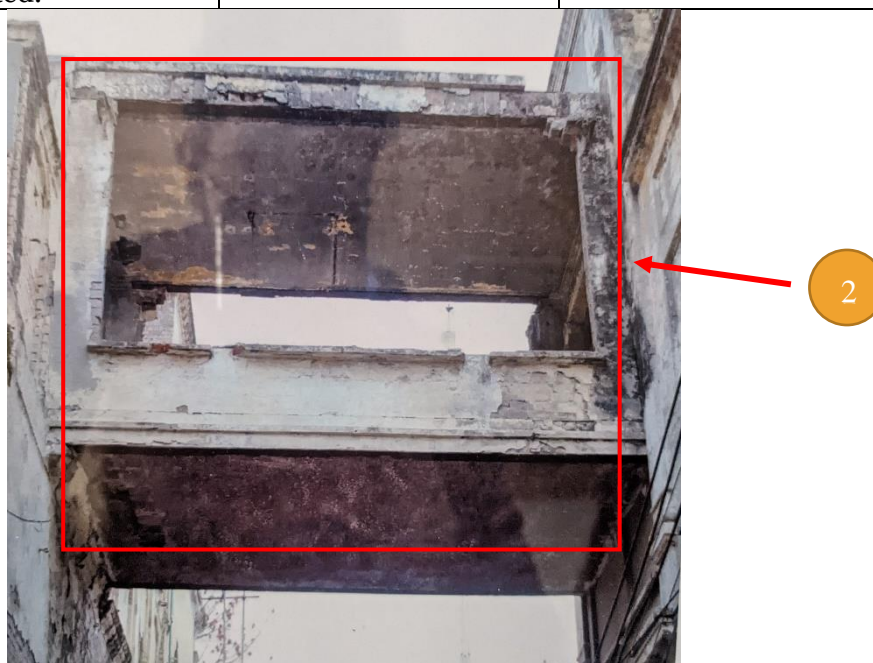
**Figure 5. Bridge Condition**

Sr. No	Decay	Cause of Decay	Recovery
2	Figure 5 shows that the bridge has suffered significant destruction. The stucco covering has deteriorated and the bricks are visible.	Climate and lack of maintenance are the main causes of its decay. Also, local materials are used for its restoration.	Proper maintenance and use of original material for restoration.

There is a bridge on the first floor of it which connects it to the next building. This bridge has suffered significant destruction, and several obstacles had to be addressed before the documentation of the site. The stucco covering has deteriorated and the

bricks are visible. Due to cheap quality local plaster, the bricks have suffered structural deformity because these bricks were more compatible with previously used stucco.

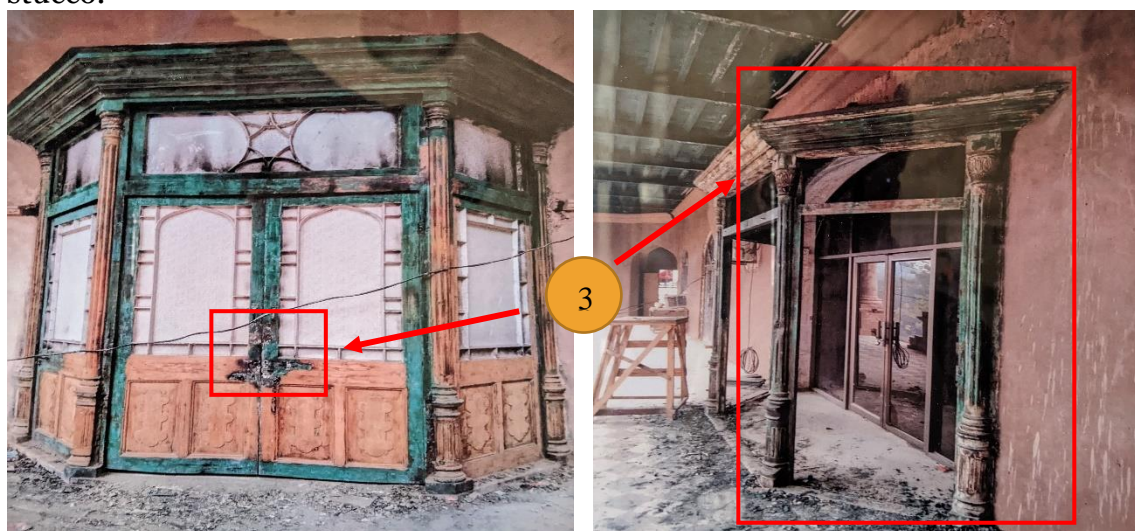
**Figure 6. Condition of Portico**

Sr. No	Decay	Cause of Decay	Recovery
3	Figure 6 shows that the building's Portico has caused severe damage and cedar wood is destroyed. To further illustrate the state of decay, the brass latchkeys that were originally used as safe locking devices have also been damaged.	Climate and lack of maintenance are the main causes of its decay.	Proper maintenance and use of original material for restoration.

Due to neglect, the building's portico, which was mostly made of cedar wood with built-in glass window panes, has completely collapsed. Destructive damage has resulted from the serious deterioration of the structural integrity. Figure 6 provides a graphic illustration of this degradation, showing the degree of the deterioration as well as the effects of inadequate care.

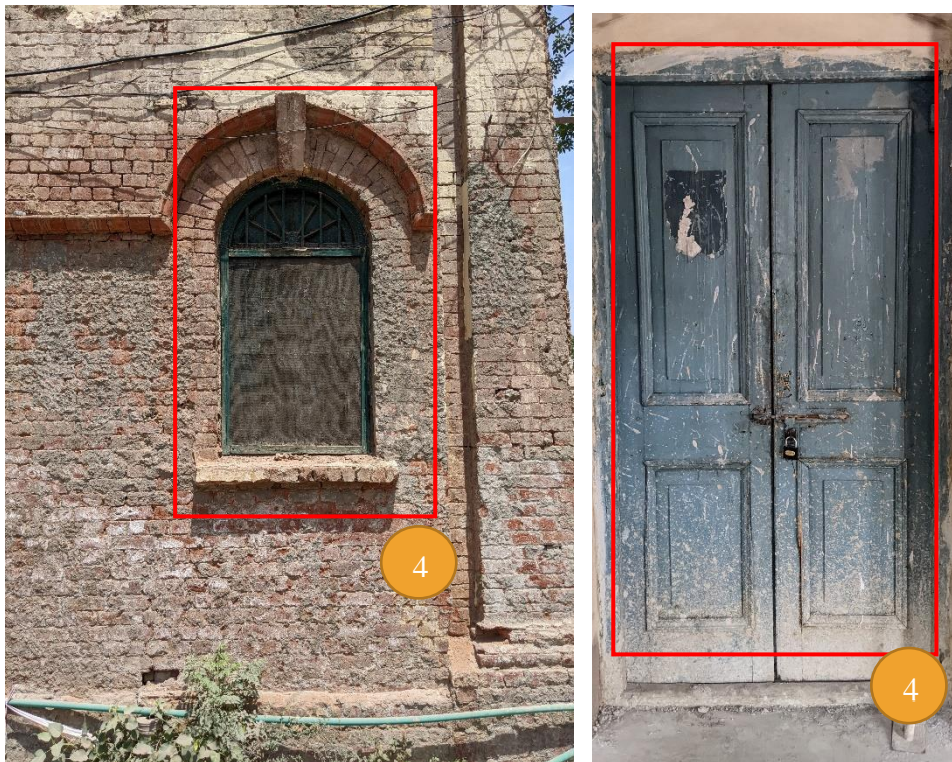
**Figure 7. Present Condition of Windows and Doors**

Sr. No	Decay	Cause of Decay	Recovery
4	Figure 7 shows that the doors and windows of the building are destroyed and lost their original form.	Climate and lack of maintenance are the main causes of its decay. Also, local materials are used for its restoration.	Proper maintenance and use of original material for restoration.

The doors and windows made up of cedar wood are also destroyed to an extreme extent. Extreme negligence has been done in taking care of these components of the building. For repairing the windows local iron sheets that were not used originally caused significant destruction to the aesthetics and originality of the building.

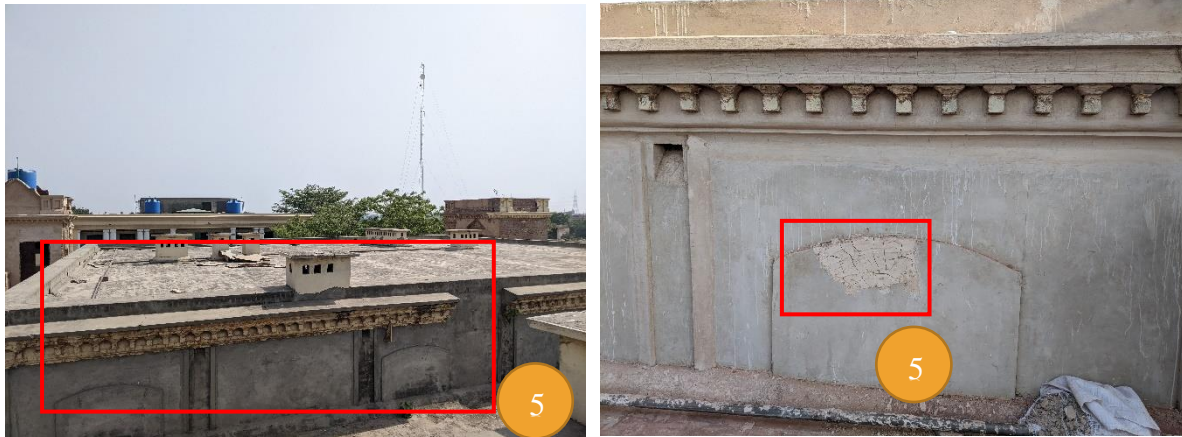
**Figure 8. Cement Destroying Walls and its Elements**

Sr. No	Decay	Cause of Decay	Recovery
5	Figure 8 shows that cement was used for its restoration at times which added fuel to the deterioration of the building.	Climate and lack of maintenance are the main causes of its decay. Also, local materials are used for its restoration.	Proper maintenance and use of original material for restoration.

Repairs were made from time to time and again with modern and non-compatible materials resulting in fast deterioration of structural members and decorative features as shown in Figure 08. For repair purposes, they used today's material which worked as fuel to fire for the deterioration of the structure of Poonch House.

Whereas, the use of modern materials like cement and concrete, while perhaps envisioned to protect the building, has unluckily exacerbated the deterioration. This highlights the significance of using compatible materials and traditional techniques in restoration projects. The fact that some restoration efforts are underway using traditional stucco (a type of exterior plaster) [17], is a positive sign, but the interior remains largely mistreated, requiring immediate attention as shown in Figure 8.

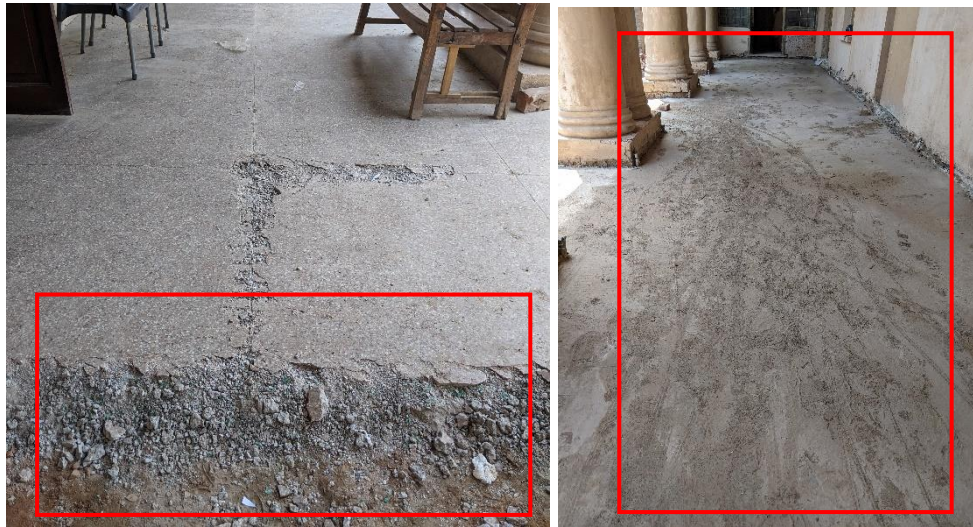
**Figure 12. Condition of Floor**

There are two types of floors used in Poonch House one is a Chips floor and the other is the wooden floor. Chips floor is mostly used in corridors and are detreated as shown in Figure 12 and wooden floor is used in halls and rooms. On roofs, we have timbers, rafters, beams, and Girders of Wood and Steel as mentioned above.

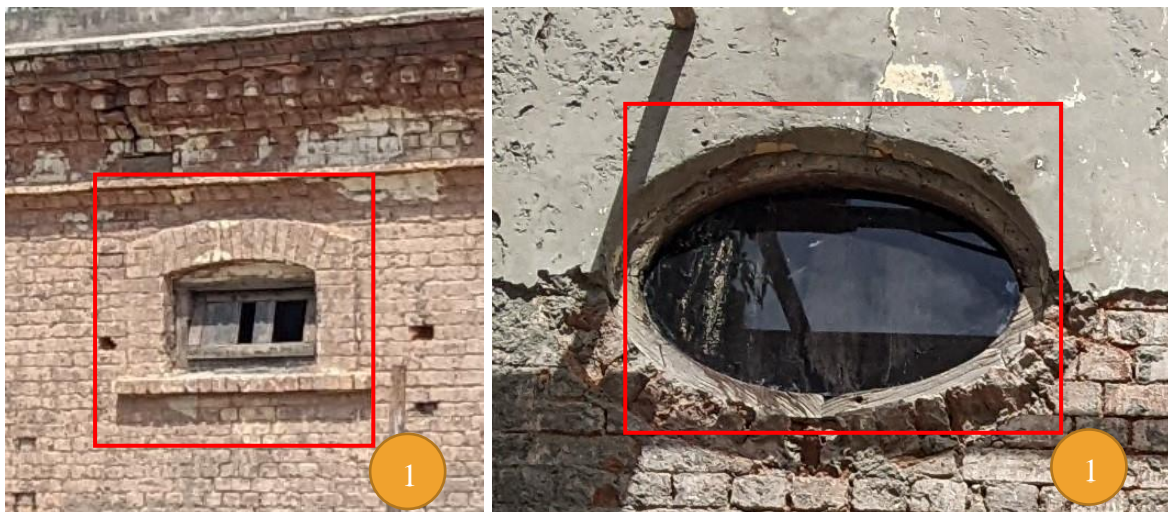
**Figure 13. Condition of Ventilators**

Sr. No	Decay	Cause of Decay	Recovery
1	Figure 13 shows two types of ventilators that caused damage and loss of their original form and shape. Also loss of stucco	Climate and lack of maintenance are the main causes of its decay. Also, local materials are used for its restoration.	Proper maintenance and use of original material for restoration.

Poonch House has around forty-six ventilators of two types as shown in Figure 13 but only fourteen of them are open. The reason behind it is considered to be Noise Pollution and Air pollution. All ventilators have the same condition as shown.

The blocked ventilators raise worries about indoor air quality and its probable impact on the building's fabric as shown in Figure 13. Restoring their functionality is crucial not only for conserving the building's original design but also for ensuring its lasting health [18].

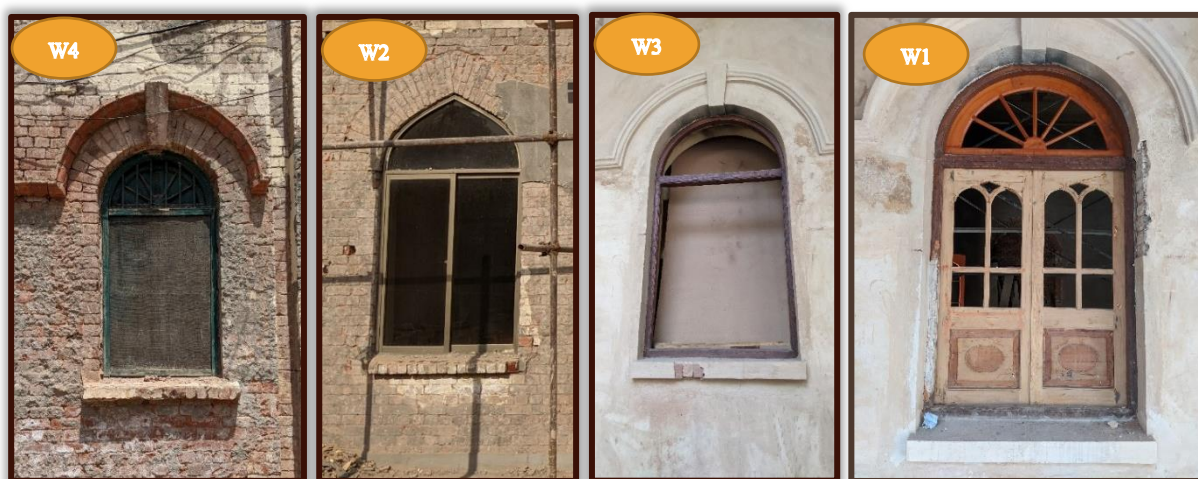
**Figure 14. Types of Windows Used**

Windows are also in the same condition as of doors but with a little change that humans changed some original windows with modern aluminum and glass windows which directly damaged the aesthetics of the building as shown in Figure 15.

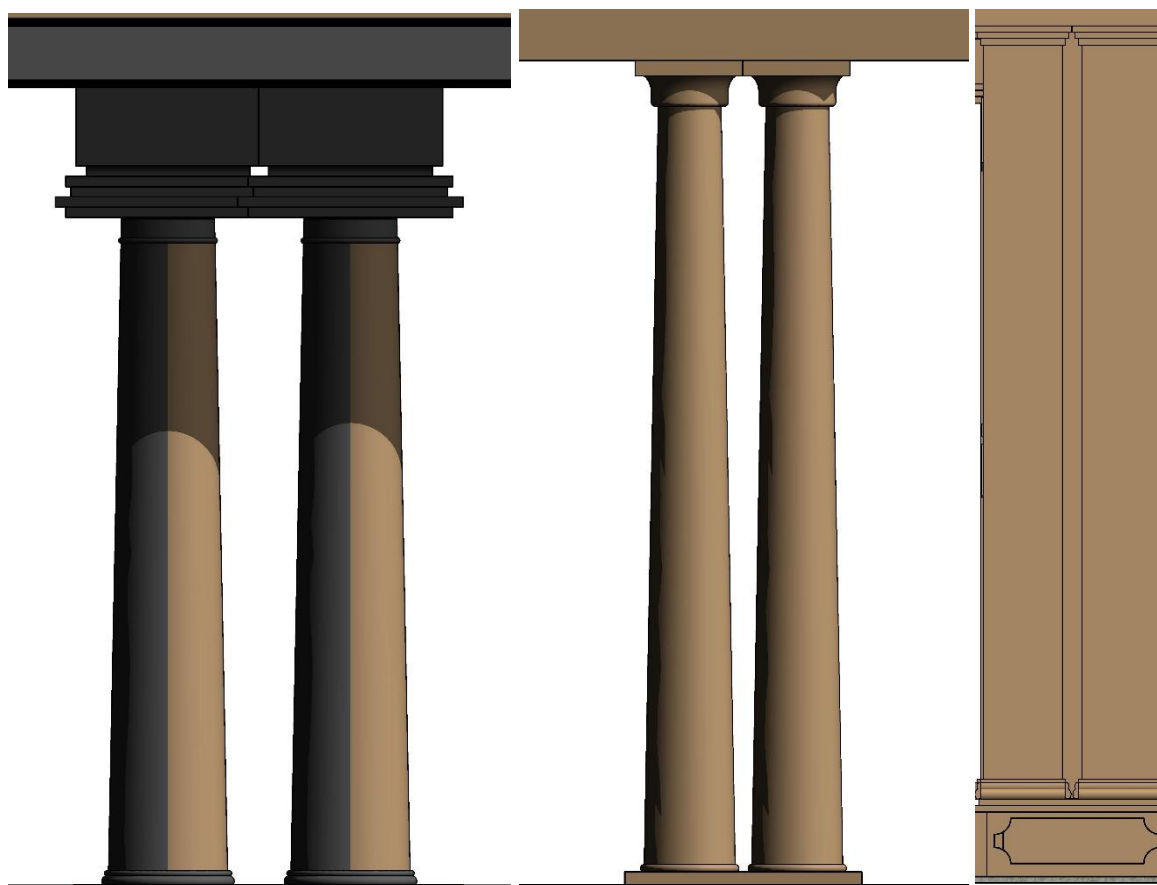
**Figure 20. Types of Columns in Poonch House**

In Poonch House Lahore there are 152 (one hundred fifty and two) columns are used and are of three types as shown in Figure 23. There are 118 (one hundred eighteen) round columns and 34 (thirty-four) square columns which are half in wall and half visible. Columns on the left side are on the first floor, columns in the center are on the ground floor and square columns are on both floors as well as on the roof floor as shown in Figures 19, 20, 21 & 22.
